Managers Report

March 2021

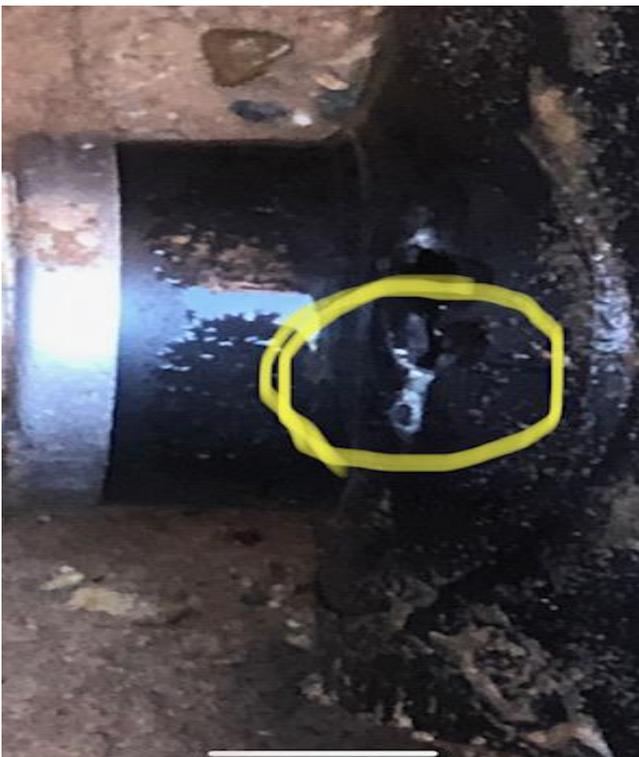
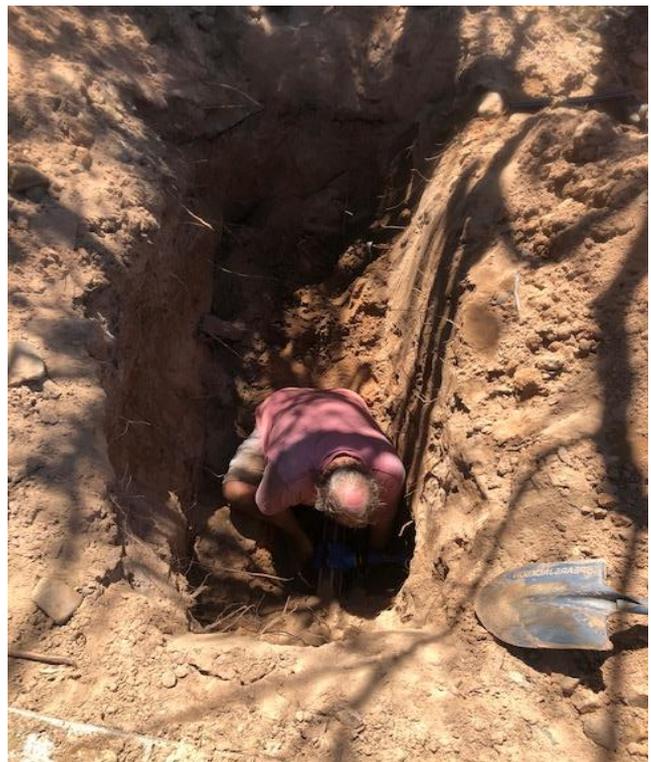
Repairs to China Club trough caps and pipework completed. Treated effluent pipe repair at Lot 121, large rock resting on top of tap'n'saddle needed replacement after large leak (pic below).
